## **CHAPTER 2. MITIGATION ACTIVITY PROGRESS**

### **2.1 Hydrology Health**

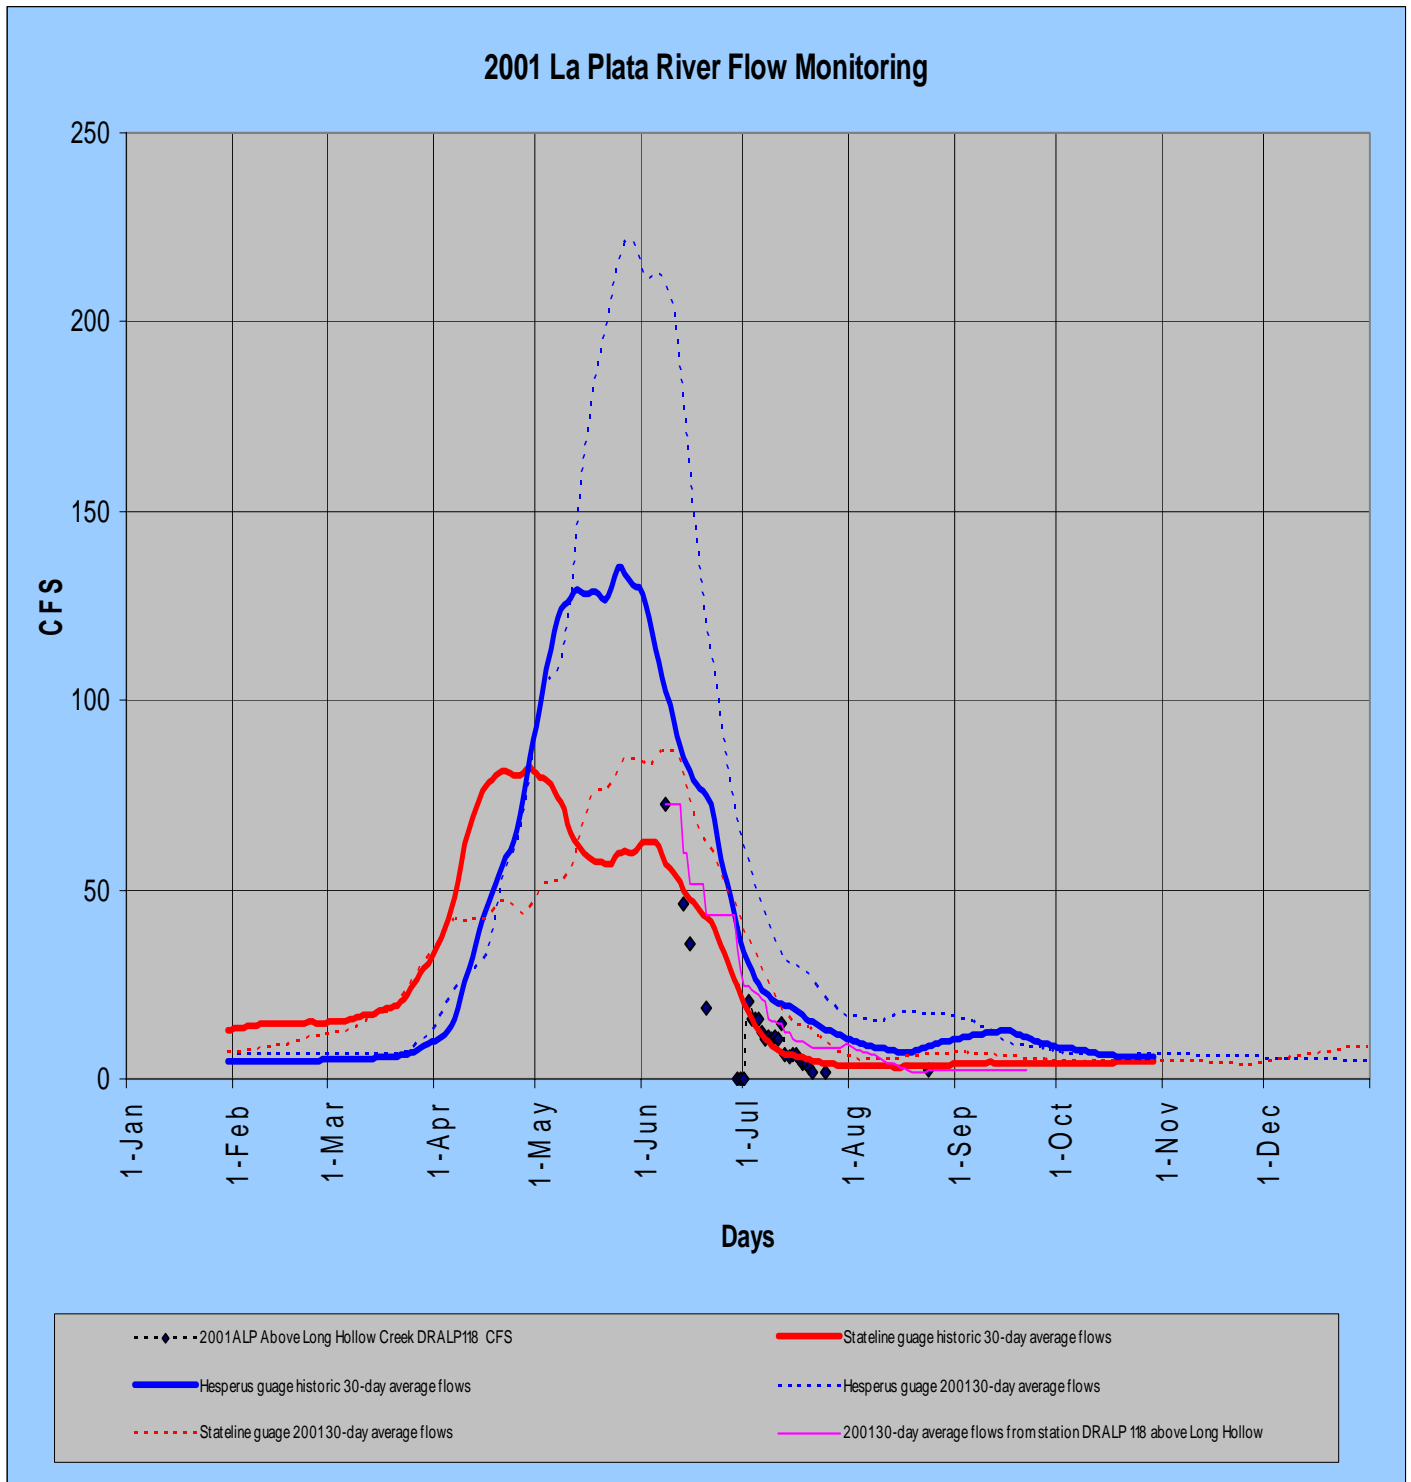
**Figure 4. 2001 La Plata River monitoring results.**

See Figures 4-6 below for the results of Reclamation’s flow monitoring for 2001-2003. Note that this data is provisional and subject to refinement. The flows described on these graphs use a 30-day average value of flows rather than a daily flow value to more clearly illustrate a typical flow value for the timeframe indicated and for enhanced readability of the graphs.

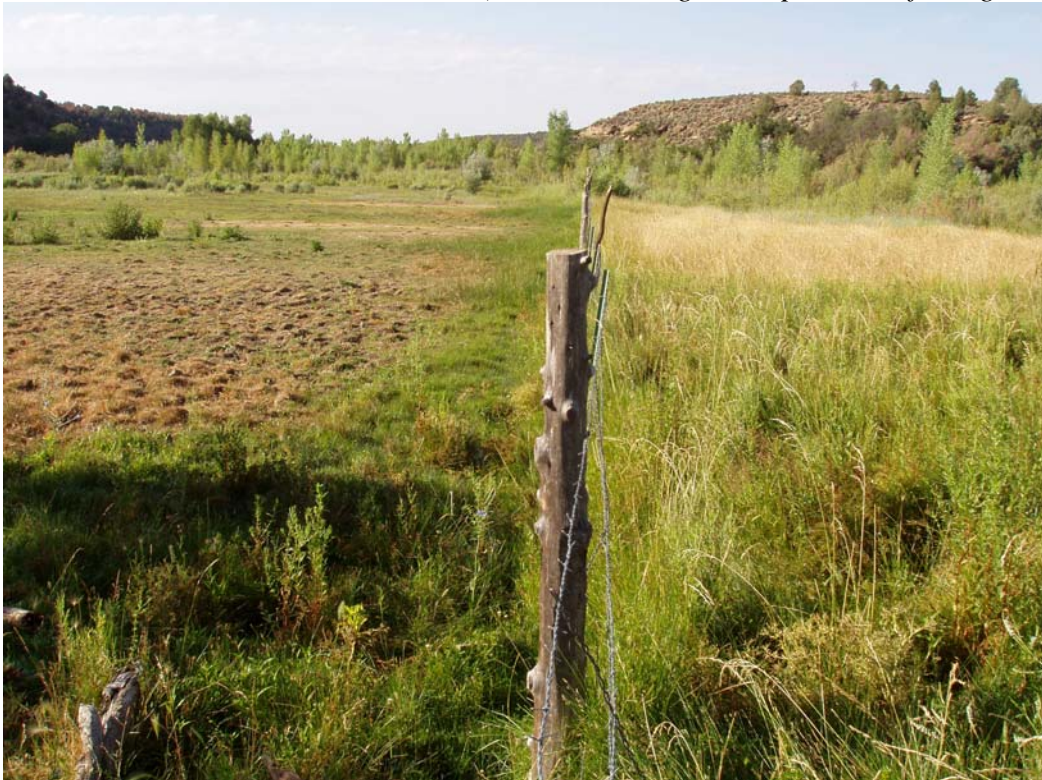
Reclamation has successfully removed all leases for grazing from the MA and is in the midst of contract development for fencing to control minor trespass grazing issues that still occur. The riparian areas will be fenced entirely in 2004. The entire MA is in need of approximately 8.5 miles of new or repaired fencing (total) which will be accomplished prior to Project completion. Reclamation has coordinated final fence design specifications with CDOW, the Southern Ute Indian Tribe and the Service.

**Figure 8. MA Tract III fence line in 2003.** *(MA is to the right and protected from grazing.)*

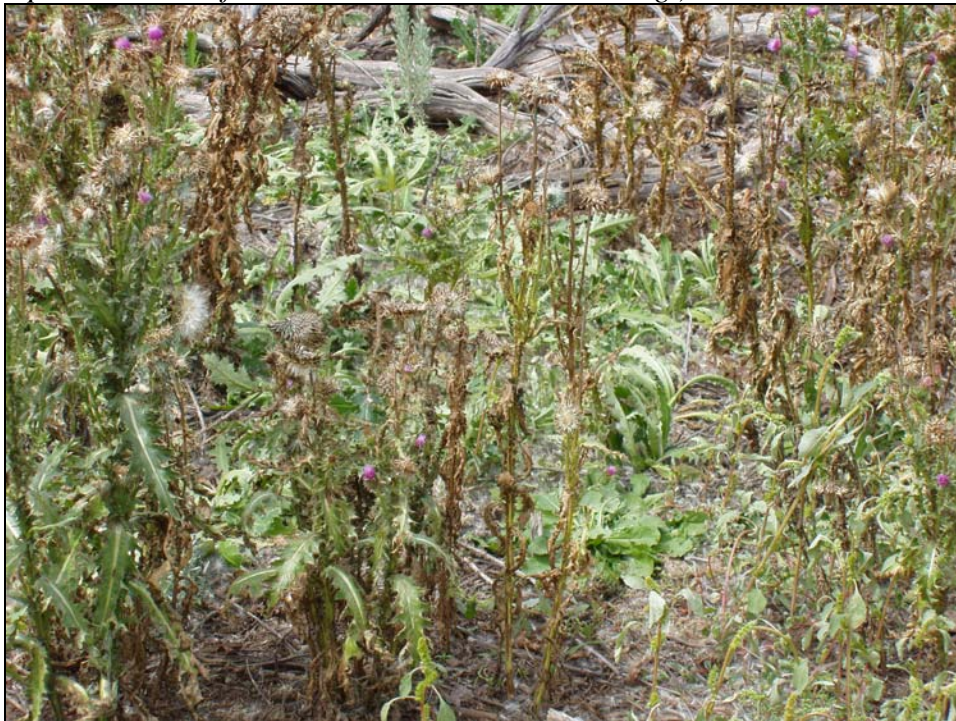
Reclamation initiated weed control actions in the fall of 2002 with a 75 acre test treatment of tamarisk and Russian olive within the southern portion of Tract II. In 2003 Reclamation began its herbaceous weed control efforts and sprayed approximately 250 acres of riparian and buffer zone habitats as a first stage in treatment for Tracts II and III. Biological (insect) controls were employed for three weed species as prescribed by state weed control insectary release guidelines. Within the 250 acres described above, approximately 150 acres of land was treated for tamarisk and Russian olive in the ongoing weed management effort. An additional 30 acres is still in need of treatment in early spring of 2004. Although treatments occurred in 2002-2003 most results will not become apparent in the monitoring transects until 2004 due to inclusion of treated plant communities in 2003 transect measurements.

**Figure 9. Photo of musk thistle, redroot pigweed and bindweed treated in summer 2003.**  
*(This photo is soon after treatment...note leaves curling.)*

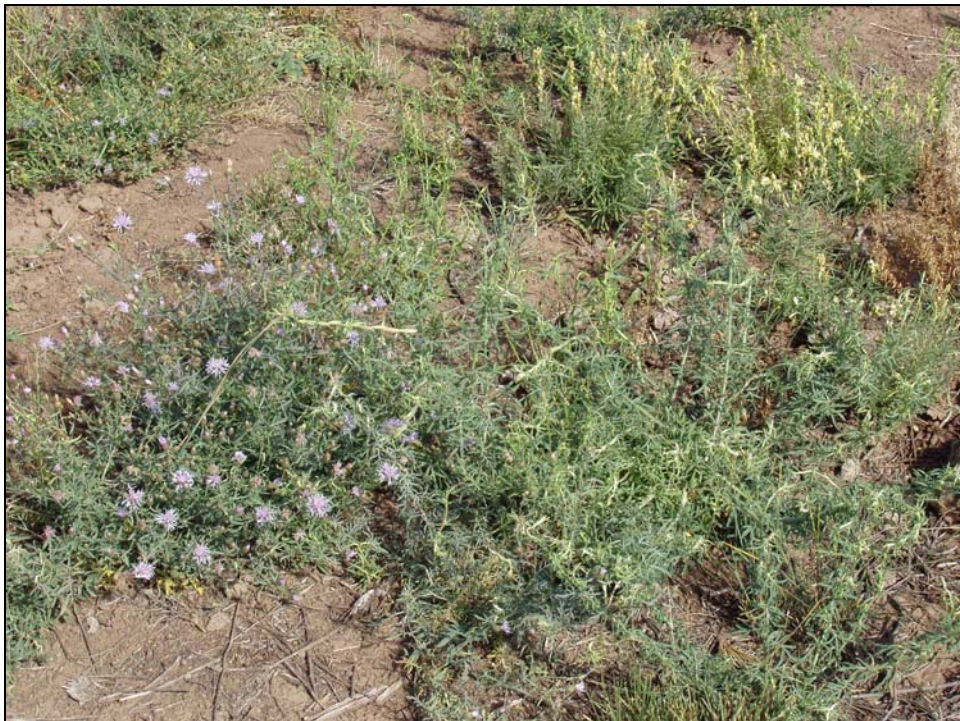
**Figure 10. Photo of spotted knapweed, kochia and yellow toadflax prior to treatment in 2003.**

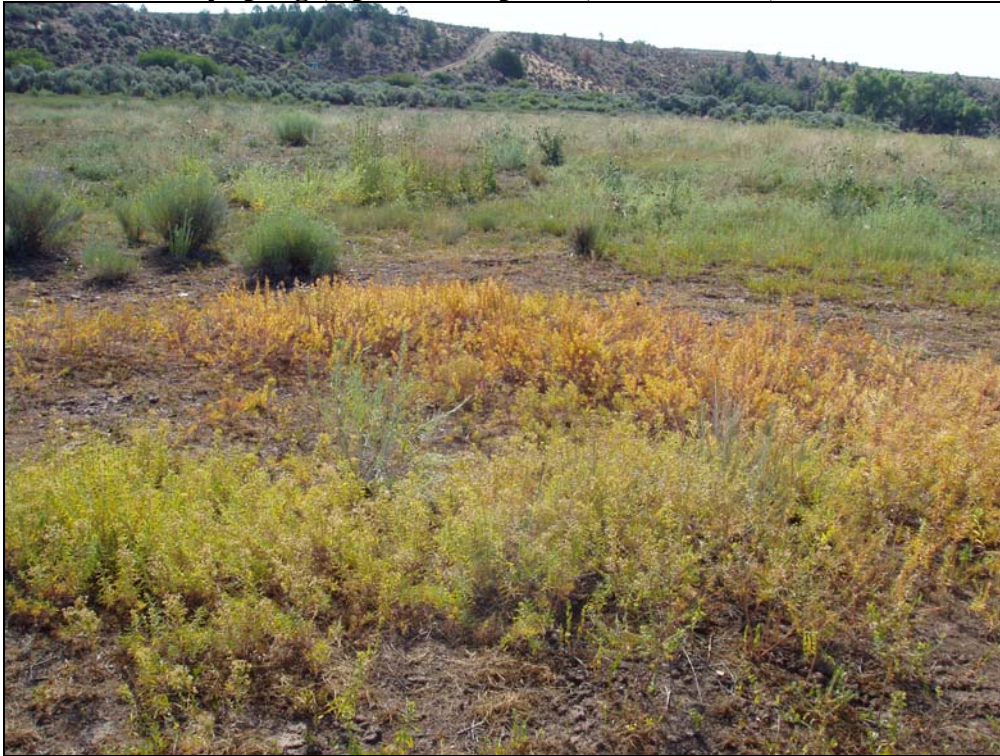
**Figure 11. Photo of leafy spurge, spotted knapweed, musk thistle, etc. after treatment.**

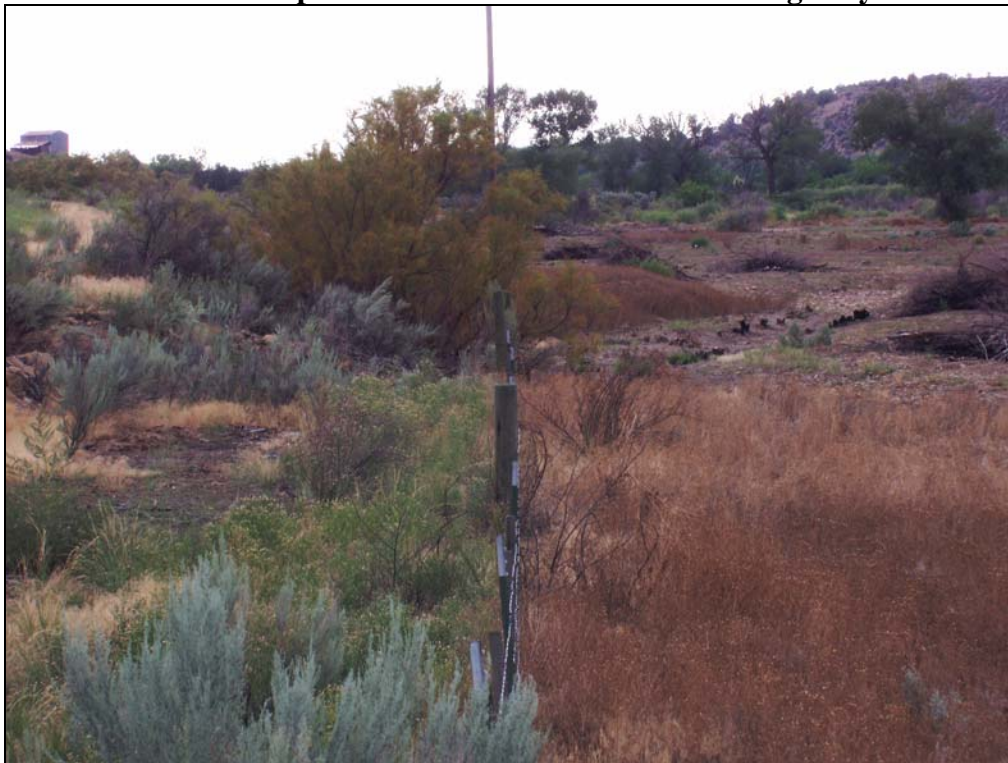
**Figure 12. Photo Russian knapweed and tamarisk treatment at highway 140 fence line.**

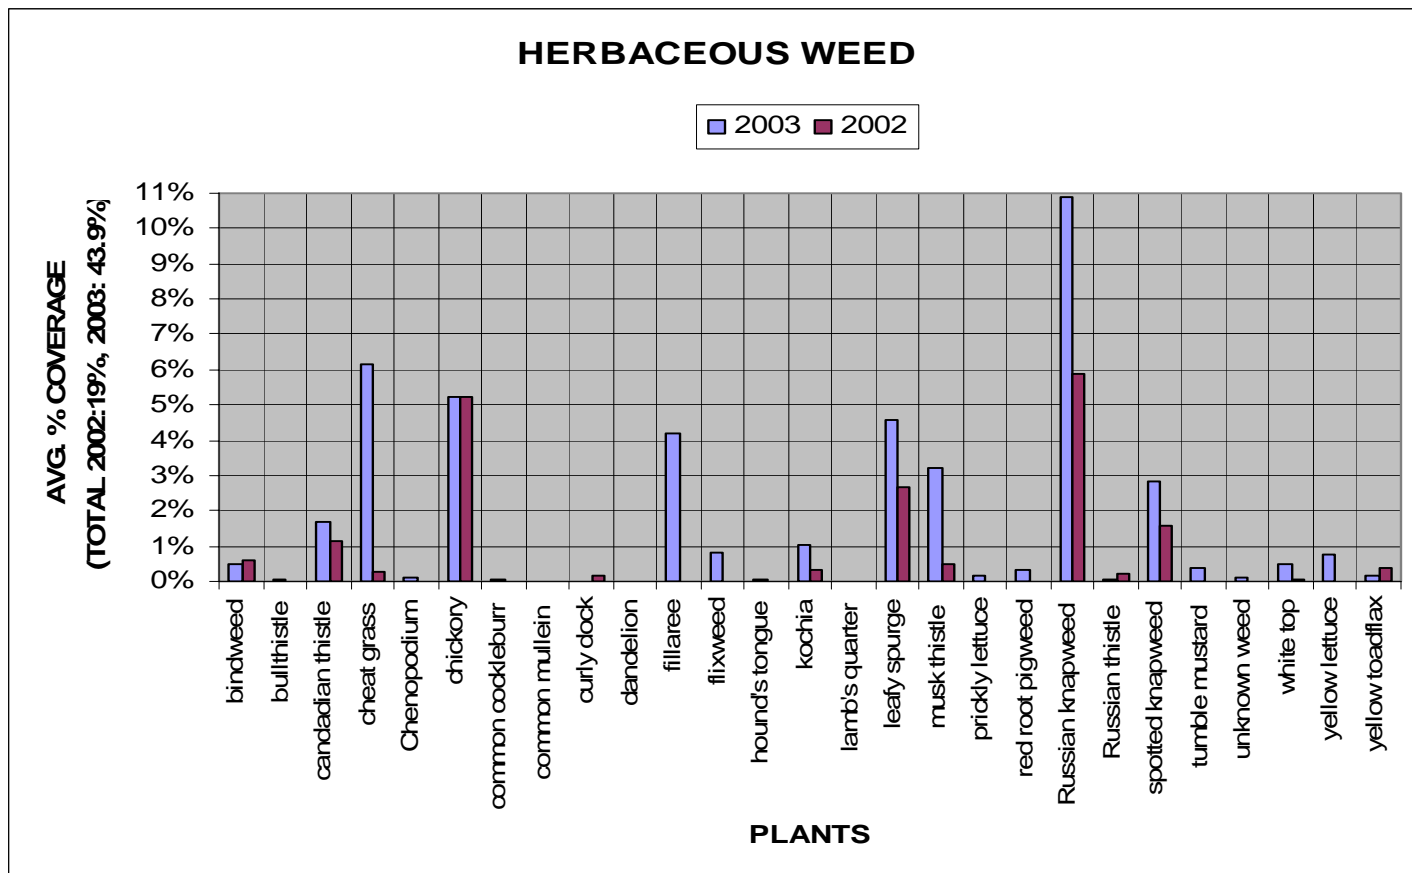
**Figure 13. Herbaceous Weed Quantified Coverage** (Note that the percentage values on the left side of these figures represents the percent of total ground coverage by the specific plant type represented by the bars.)

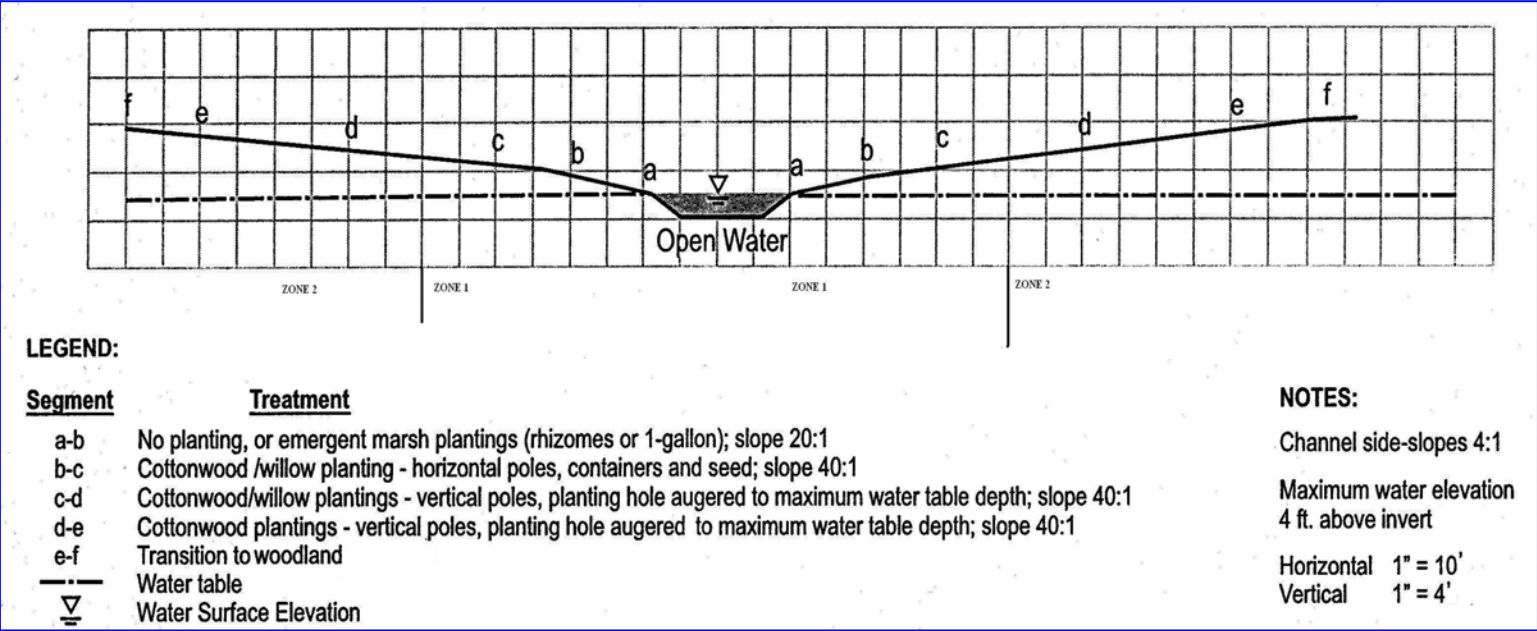
**Figure 15: Cross-sectional Planting Zones.**

Reclamation has committed to a certain level of native plant community establishment and enhancement within the MA relative to weed treatment and stream restoration vegetation or substrate disturbances. Below in Figures 15, 16

and 17 (modified from CH2MHILL), are typical planting descriptions for this type of project. These figures relate to the information presented in Figure 7 describing channel restoration. Table 4 above lists the woody species being grown for planting in 2004.

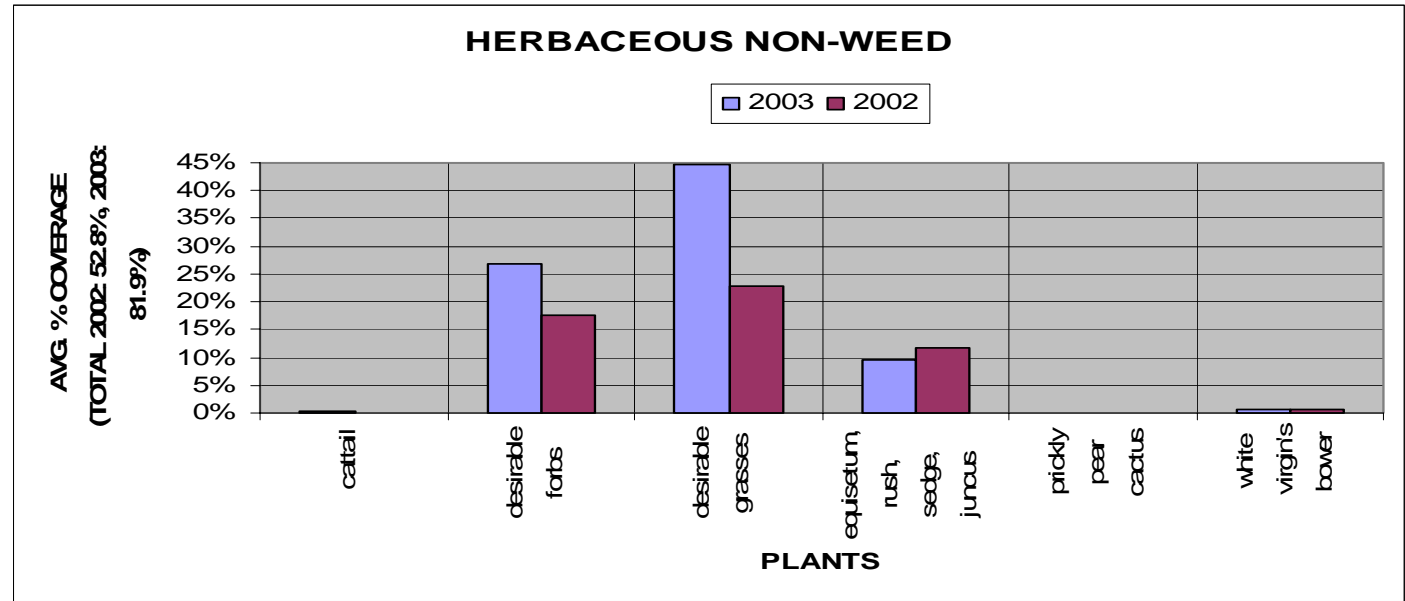
Water conditions were significantly different between years (see La Plata River flow monitoring above) and therefore some coverage readings related to foliar cover density variation is likely due to relative water availability. There is an across the board increase in vegetative densities which very likely also reflects cattle grazing removal from most reaches of the monitored river corridor (note that non-Project lands are included in the MA vegetation monitoring for comparison over time and many acres of riparian habitat so included are still subject to relatively intensive grazing pressure. See figure 8).

**Figure 19. Herbaceous Native Species Quantified Coverage** (Note that the percentage values on the left side of these figures represents the percent of total ground coverage by the specific plant type represented by the bars.)
